A Hispanic Car Wash Supervisor Died When an Air Tank Exploded in a Car Wash Equipment Room

California Case Report: 05CA010

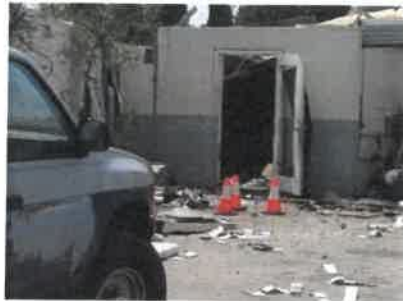
Exhibit 1. The equipment room after the explosion.

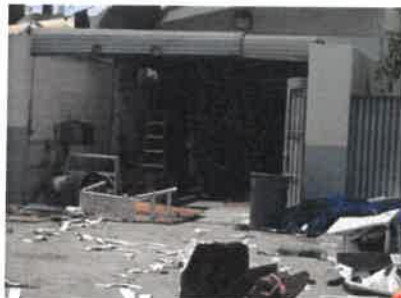
Exhibit 2. The car wash tunnel entrance after the explosion.

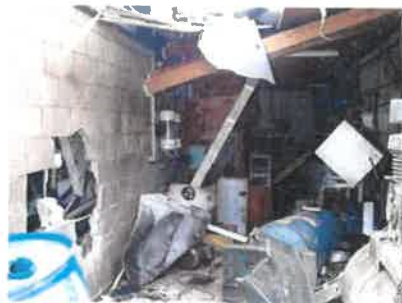
Exhibit 3. The inside of the equipment room after the explosion.

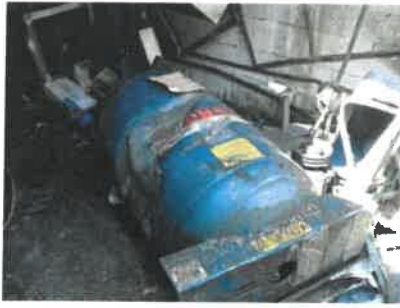
Exhibit 4: The second air tank inside the equipment room, which did not explode.

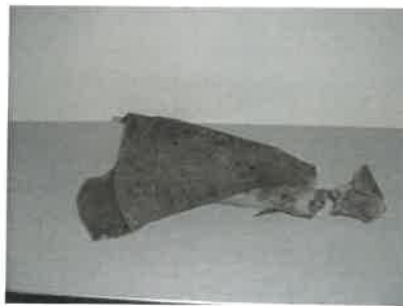
Discussion: The test results of a failure analysis laboratory concluded there were products of combustion in the air tank that were most likely caused by the wrong viscosity of oil being used in the air compressor. The oil in an air compressor serves two purposes. First is to lubricate the compressor as it operates and second, to help cool the compressor and the compressed air it produces. The oil must be of a certain type and viscosity in order to produce the desired results. Manufacturers of air tanks and compressors usually recommended what type of oil to be used in their product. When OEM oil is not used, studies have shown that the oil may leak past the seals and gaskets and form carbon deposits in the supply line. As the diameter of the supply line decreases because of the carbon deposits, the compressed air, which is already at a high temperature, will increase even more, to the point where it might be possible to ignite the carbon deposits. If this should happen, and a piece of ignited carbon gets into the air tank, it could cause an internal explosion. This type of explosion would vary in intensity based on the amount of oil vapor within the tank. Air tank relief valves are not designed for this type of activity, and the air tank could explode, causing severe damage and injury. Although this type of event is rare, it has happened in some businesses and industry throughout the country. The practical prevention measure to take to avoid such an incident is to maintain air compressor equipment in a safe operational condition and to use only the grade of oil recommended by the manufacturer.

Exhibit 6: A piece of the exploded tank showing the inner wall and oily substance.

Recommendation #1: Ensure that air tank and compressors are inspected regularly and maintained in a safe and operational condition, are serviced on a regular basis using OEM (original equipment manufacture) oil, and that all repairs and servicing are documented.
